Re: 1600 Block Melody Lane Speed Table Construction
Vail's Concrete, LLC

The purpose of this memorandum is to evaluate traffic safety concerns for the 1600 block of Melody Lane. This item was discussed at the October 9 Traffic Safety Committee meeting, and the following items were noted that needed evaluation:

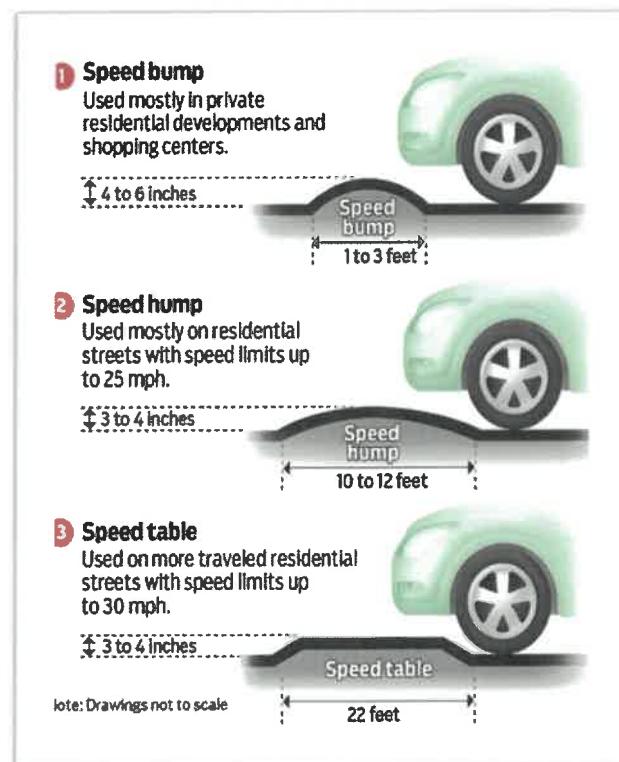
Speed bumps, not to be confused with speed humps, are devices that can startle and cause discomfort to motorists due to their abrupt design. This drastic shift in vertical elevation may cause vehicular damage or loss of control if used improperly. In general, speed bumps should not be used on public roadways.

A speed hump is a raised area in the roadway pavement surface extending across the entirety of the roadway. Speed humps have geometric design features that create a gentle vehicle rocking motion that causes most vehicles to slow to approximately 15 miles per hour (mph) or less at each hump, and approximately 25 mph to 30 mph between properly spaced humps.

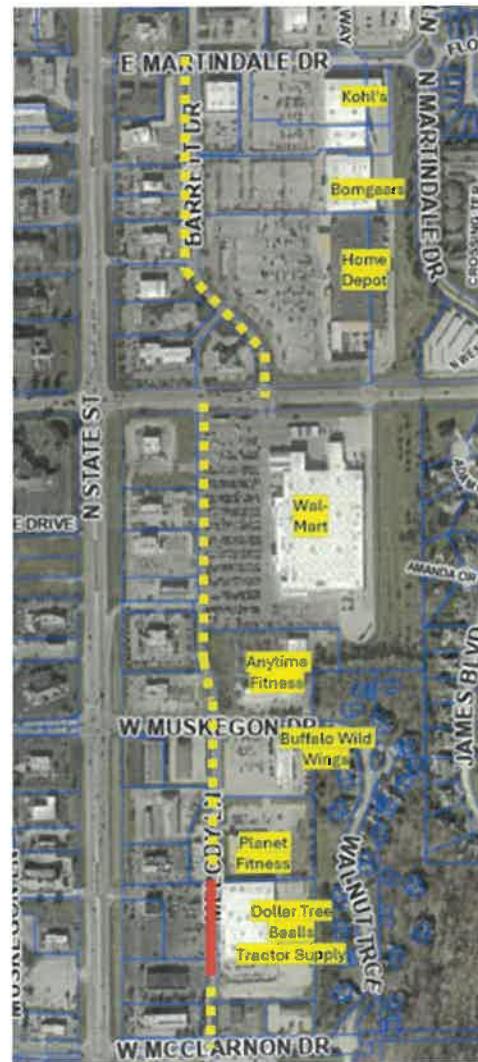
Diversion of Traffic Away from the Entrances: hindsight would suggest that this is how the site should have been re-platted in 2005. Note how Melody Lane is in front of the current Wal-Mart location and Barret Drive in front of the Home Depot complexes where the frontage

access road is away from the customers entering and leaving the stores. Granted, those other lots are deeper lots and have more room for a public street.

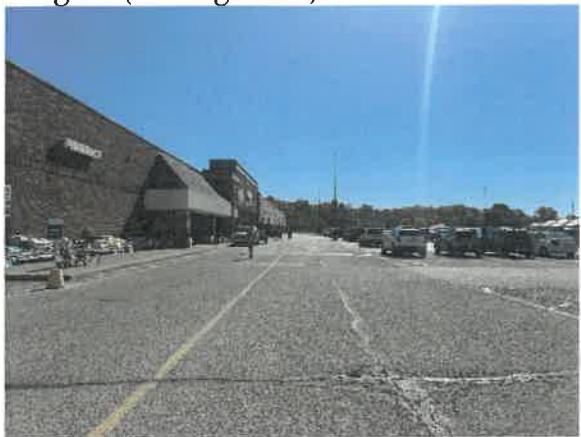
Kroger's (looking south)

Big Box Store Examples: Since this section of Melody Lane functions as a front drive aisle as found at most big box store developments, the other big box store developments along the east side of N. State Street are discussed for consideration and comparison.

Reviewing the comparison table, it illustrates that this Melody Lane segment, acting as a big box front drive aisle, contains more obstructions and less safety features than that of nearby private parking lot big box front drive aisles. Note that the differences in landscaping and other features may be a product of the applicable zoning codes at the time of development.

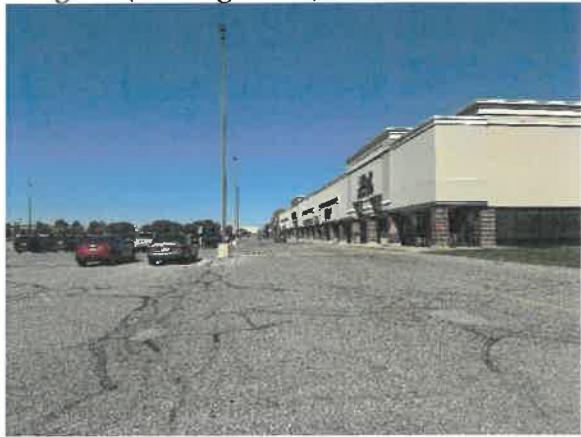
Kroger's (looking north)

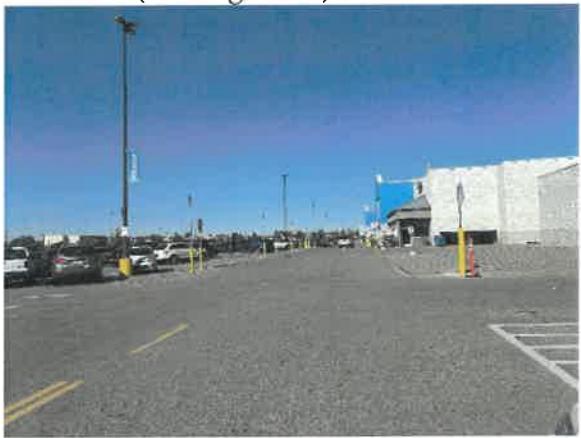
Wal-Mart (looking north)

It should also be noted that the “Stop Here for Pedestrian” signs at Wal-Mart are MUTCD compliant signs (R1-5b). There are other signs that are placed at crosswalks in the middle of the street, but they do create problems with snow fighting operations.

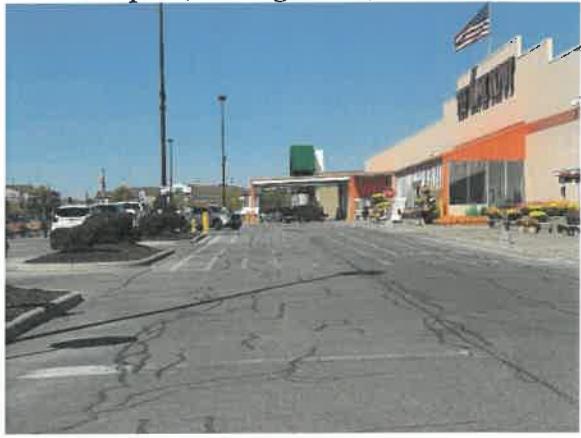
Home Depot (looking north)

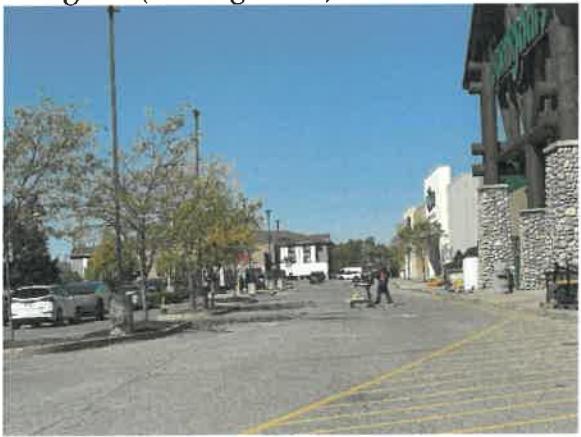
Bomgaars (looking north)

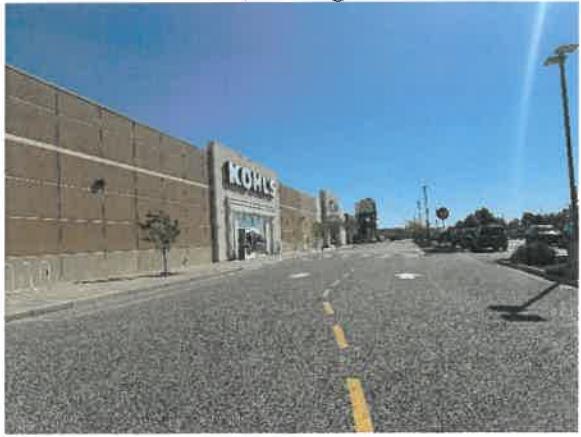
Kohl's / PetSmart (looking south)

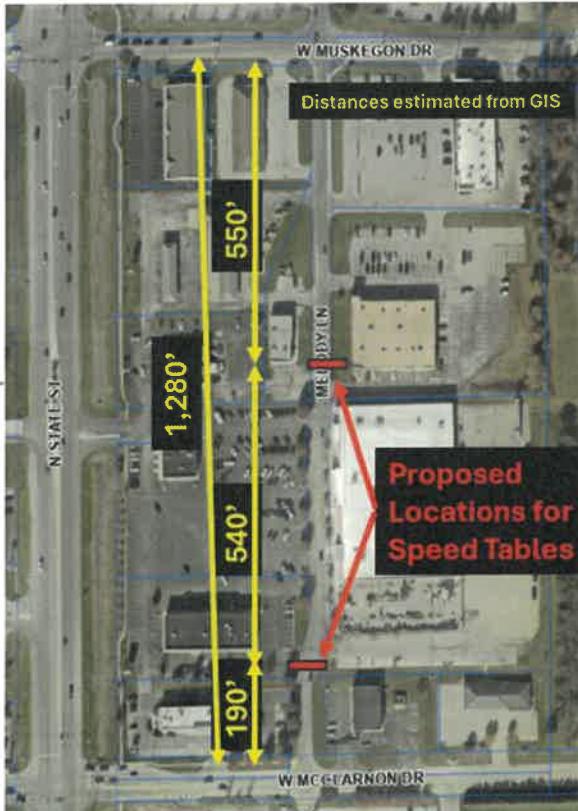
Guidance regarding the design and spacing of speed tables was reviewed from resources published by the Federal Highway Administration¹, including the *Institute of Transportation Engineers (ITE) Guidelines for the Design and Application of Speed Humps*. These guidelines recommend spacing speed humps or speed tables between 260 and 500 feet. Several jurisdictions have refined these recommendations further, including:

Proper placement of the first speed table in a series is also critical. The ITE guidelines state that “*the first speed [table] in a series is normally located in a position where it cannot be approached at high speed from either direction.*” To achieve this, speed tables are typically installed within 200 feet of

The spacing between the two proposed speed tables is approximately **540 feet**, which slightly exceeds the ITE upper recommendation of 500 feet but remains consistent with spacing standards used by jurisdictions that have adopted refined guidelines.
